# **BUILDING ANALYSIS REPORT**

**661 Park Avenue East  
Mansfield, OHio 44905**

**780 Park Avenue West  
Mansfield, OHio 44903**

**Revised: October 14, 2024**

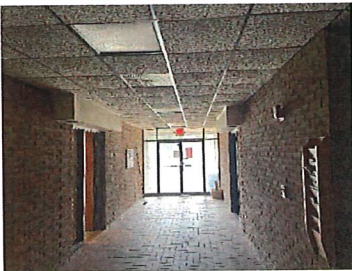
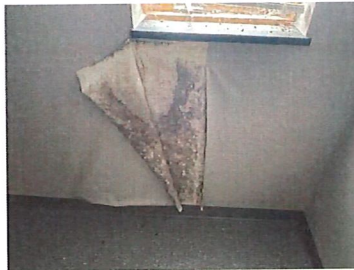
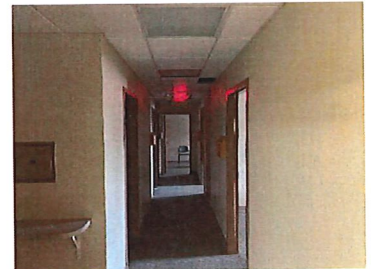
661 is organized in pods that make it ideal in terms of layout for providing staff respite from client interaction as well as maintaining separation of the various populations served. The building is in generally good condition and could be used with minimal reconfiguration of the rooms. However, there is evidence of mold growth on some of the exterior walls. Whether this is simply from sitting vacant for a few years or indicative of a larger water infiltration problem is not within the scope of this report to determine, but is certainly something to take into consideration. There is signs of roof leaking and damage to interior from said leak. The leak does appear to have been addressed at some point, but the damage not repaired.

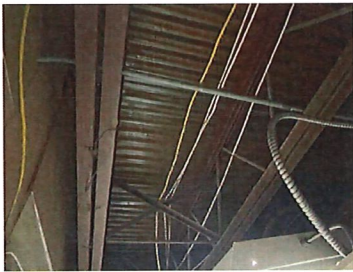
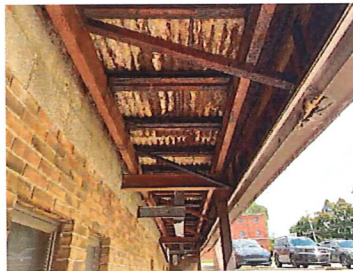
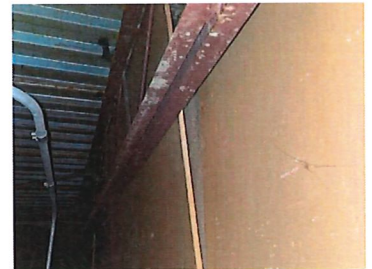
The exterior brick façade was in very good condition with a few cracks visible. These cracks would need to be addressed to prevent further deterioration. Also the exterior brick walls used as handrails for the exterior concrete stairs will need to be rebuilt to repair damage from the weather (i.e. moisture and freeze/thaw cycles).

The elevated walkway along the front of the building was structurally in poor condition. The floor joists had the top cord extensions supporting the exterior concrete deck and guard wall system. The joists extensions were not treated to be in an exterior environment and therefore had deteriorated considerably. Additional steel framing was added to prop up the concrete deck. The steel was also not treated to be in an exterior environment.

It could not be determined how far the deterioration had extended along the top chord of the joists. Masonry would have to be removed to determine if the deterioration of the compromised joists has extended to the bearing required for the floor system.

The present walkway structure should be removed and a new system designed and installed if this access to the building is to be maintained.

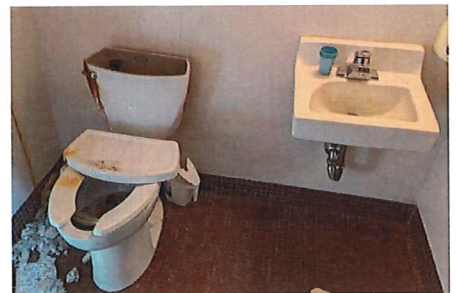
LOWER-LEVEL FIXTURES

- I. Fixtures
  - A. Plumbing fixtures have remained unused while the building has been sitting vacant. The fixtures appeared to be in good condition on the upper-level. The lower-level fixtures appear to have been unused for an extended period and will require additional maintenance to restore them to an operational level. Some of the lower-level fixtures may need to be replaced based on our observations.
    1. Toilets are tank type in each restroom.
    2. Lavatories are wall mounted type in each restroom.
    3. Counter-mounted, drop-in stainless steel sinks are installed in each exam room.
  - B. The drinking fountains are outdated, and we recommend replacement.

- I. Review the existing plumbing fixtures and domestic water heaters throughout the building. Replace any deficient fixtures with equivalent units.
- II. New showers (15 total) are to be installed under the proposed plan, the existing domestic hot water system and equipment will most likely need to be upsized. The domestic water system and main service size will also need to be reviewed.

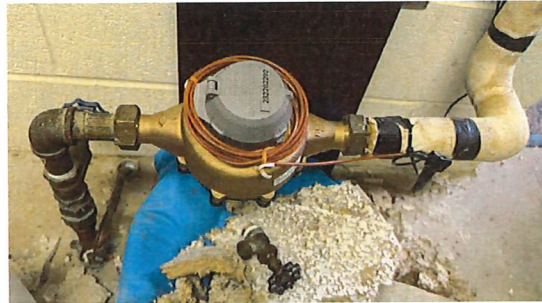
WATER ENTRY AND METER

- A. The building is supplied by a 1" water main that enters through the lower-level mechanical room. A new water meter appears to have been installed but never used. This size should be sufficient for the intended use.

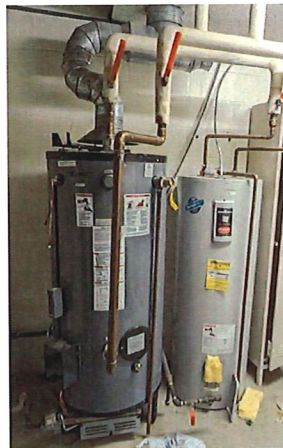
WATER HEATERS

- B. Two domestic water heaters are located in the same mechanical room as the water entry.
1. One 120-gallon gas-fired tank and one 80-gallon electric water heater are connected to the same domestic hot water system. Both appear to be in decent condition and could remain.
    - a. Based on the electric unit's serial number, it appears to be from 2018. There is no visible manufacturer tag on the gas-fired unit.

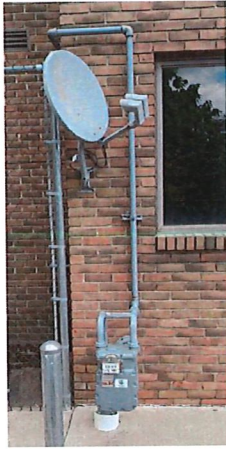
GAS ENTRY WITH METER  
AND REGULATOR

- A. A 2" natural gas main is extended to a meter and regulator located on the southwest side of the building. A 1 1/2" line is extended into the building to serve the furnaces and the domestic water heater. Some of the rooms also had gas turrets that appeared to be connected to the natural gas system that will be removed.
- B. The capacity of the gas main will need to be verified after the gas-fired kitchen equipment loads are verified (if applicable).

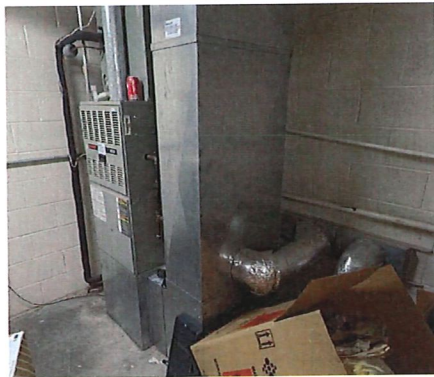
NEWER FURNACE

- A. The building is equipped with six gas-fired furnace systems, each accompanied by its own condensing unit. The furnace units range in age, with two (2) original units dating back to 1982 (as indicated by the serial number) and four (4) newer replacements installed in the mid-2000s.

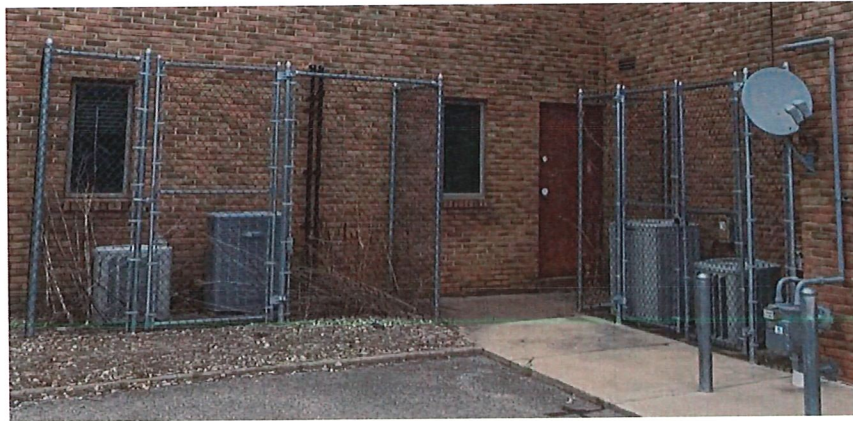
CONDENSING UNITS ON SOUTH SIDE

- 1. None of the condensing units (CU) appeared to be original to their corresponding indoor units. It is assumed that the condensate units were replaced when they failed or when the associated indoor unit furnace was replaced.

2. The units appear to be from the mid-2000s, similar to the newer furnace systems. They may remain for the newer systems; however, we recommend replacing the units associated with the older furnaces if they are being replaced.
3. We would anticipate a lifespan of 15 to 20 years for residential condensing units such as these, so most are approaching or have exceeded their expected service life.

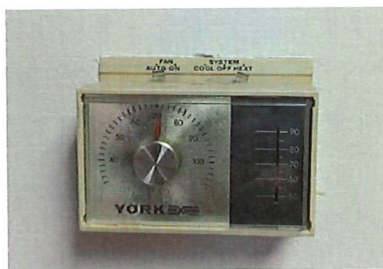
OLD THERMOSTAT

- A. Each furnace unit appeared to be controlled by a basic wall-mounted thermostat. Some had newer scheduling capabilities, while others appeared to be the original, basic models.

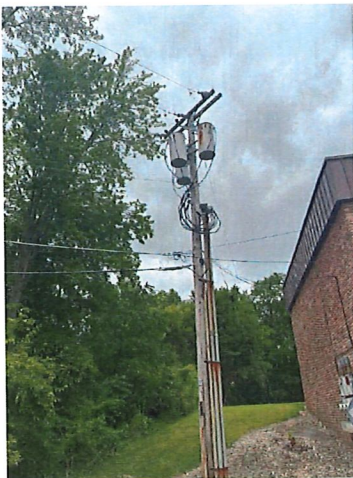
SERVICIE TRANSFORMER

The electrical service is currently comprised of a 150KVA, 208/120V, 3Ø 4W pole mounted service transformer located to the West of the facility. The transformer feeds two (2) wireway troughs that serve seven (7) total meters. Each meter serves a separate tenant space and a house panel. The existing wireway and meter arrangement is in poor condition with rusting on several components. The panelboards throughout the facility appear to be in adequate condition. Replacement of individual panelboards may be necessary based on capacity needed at each location and quantity of breakers.

- I. The existing utility transformer is adequately sized to support the facility. Considering the condition of the service equipment we recommend replacing the main service meter center with a new 600A, 208/120V, 3Ø panelboard. This would also reduce the fixed utility cost associated with having multiple meters.
- II. Branch circuit panelboards shall be replaced as deemed necessary to increase capacity or breaker space availability as deemed necessary. In general the location of the branch circuit panelboards appears to be adequate.

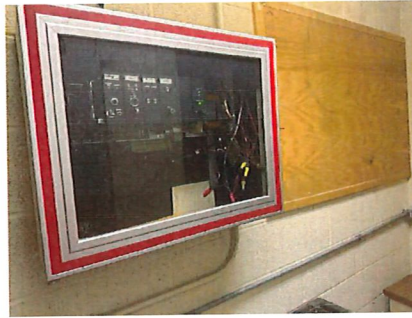
EXISTING FIRE ALARM SYSTEM

An existing Simplex fire alarm system is located on the lower floor. The panel has been mostly disassembled and needs to be replaced.

We recommend installing a new addressable fire alarm system to support the facility. Notification and initiation devices would be installed throughout to meet current building and fire codes.
