SUBSURFACE INVESTIGATION REPORT

**FORMER YMCA GROUNDS
455 PARK AVENUE WEST
MANSFIELD, OHIO 44906**

**GROUND PENETRATING RADAR SCAN
INVESTIGATION REPORT**

Summary of Underground GPR and EMI Investigation for Buried Structures

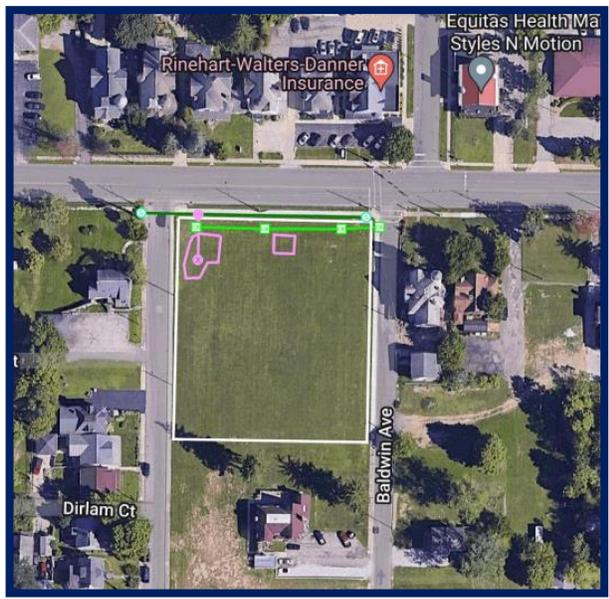
Results of the ground penetrating radar (GPR) and electromagnetic induction (EMI) verified three (3) areas on the property with highly irregular anomalies below ground surface (bgs) at a depth of approximately 2' bgs. Two (2) large anomalies were located along the northern edge of the approximately 1.25 acre site and another along the back southwest corner (not quite as definitive as the northern two (2) locations). It was these three (3) areas that soil borings were advanced to verify the presence of C&DD. Refer to figures below showing locations of suspect debris field(s). Table No. 1 provides a summary of debris fields and GPS coordinates.

GPR AND EMI VERIFIED BGS DEBRIS FIELDS ON NORTHERN EDGE OF SITE

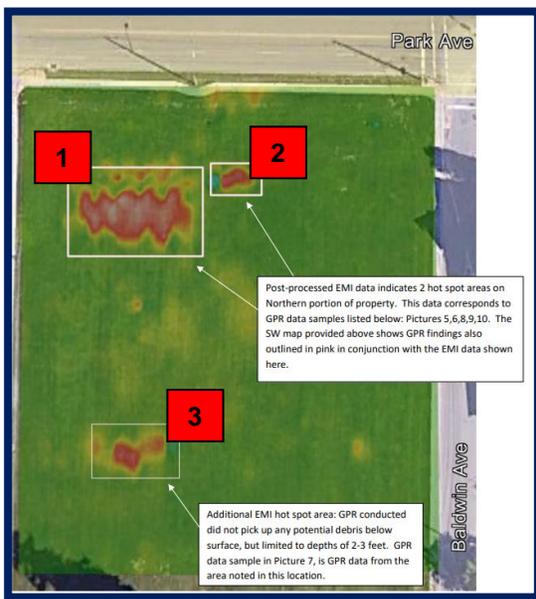
TWO NORTHERN LOCATIONS; EMI PICKED UP A 3RD ON SW CORNER

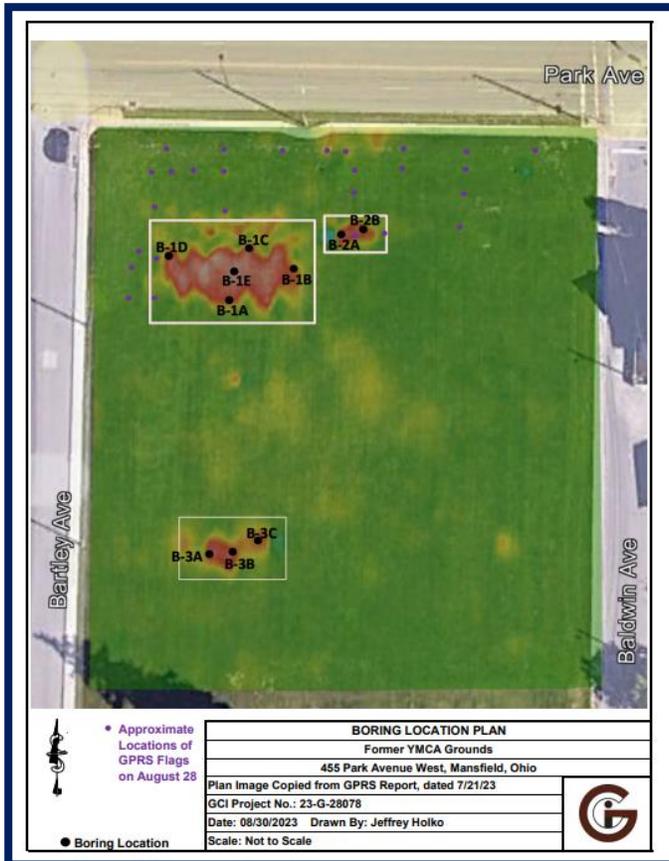
SOIL BORING LOCATIONS

CEI mobilized a truck-mounted rotary drill rig (with automatic sampling hammer) to the site on 28 August 2023 and drilled ten (10) standard penetration test borings, 4.5” in diameter. Five (5) borings (B-1A to B-1E) were performed at the northwest anomaly area (Hot Spot #1), two (2) borings (B-2A & B-2B) were performed at the north-central anomaly area (Hot Spot #2), and three (3) borings (B-3A to B-3C) were performed at the southwest anomaly area (Hot Spot #3).

- Borings B-1A to B-1E extended to a depth range of 5.5’ to **11.3’**. Each boring terminated with auger refusal in fill.
- Boring B-2A extended to a depth of 3.5’, where auger refusal in fill was encountered. Boring B-2B encountered fill to a depth of 5’. Below the fill, we encountered natural soils to the termination depth of 9.5’.
- Borings B-3A & B-3B encountered fill to respective depths of **8’** and 6’. Below the fill in both borings, we encountered natural soils to the termination depths of 9.5’. Boring B-3C extended to a depth of 6’, where auger refusal in fill was encountered.

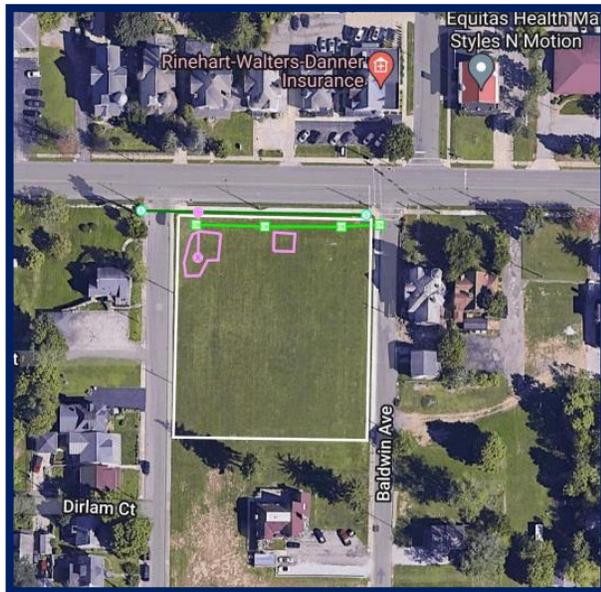
GPR AND EMI VERIFIED BGS DEBRIS FIELDS ON NORTHERN EDGE OF SITE

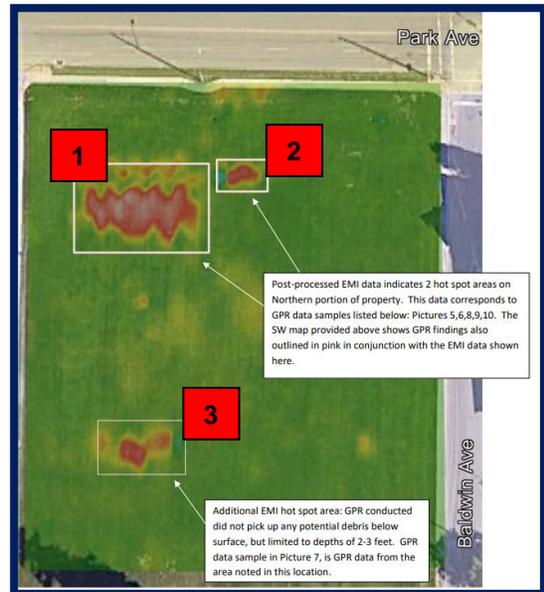
TWO NORTHERN LOCATIONS; EMI PICKED UP A 3RD ON SW CORNER

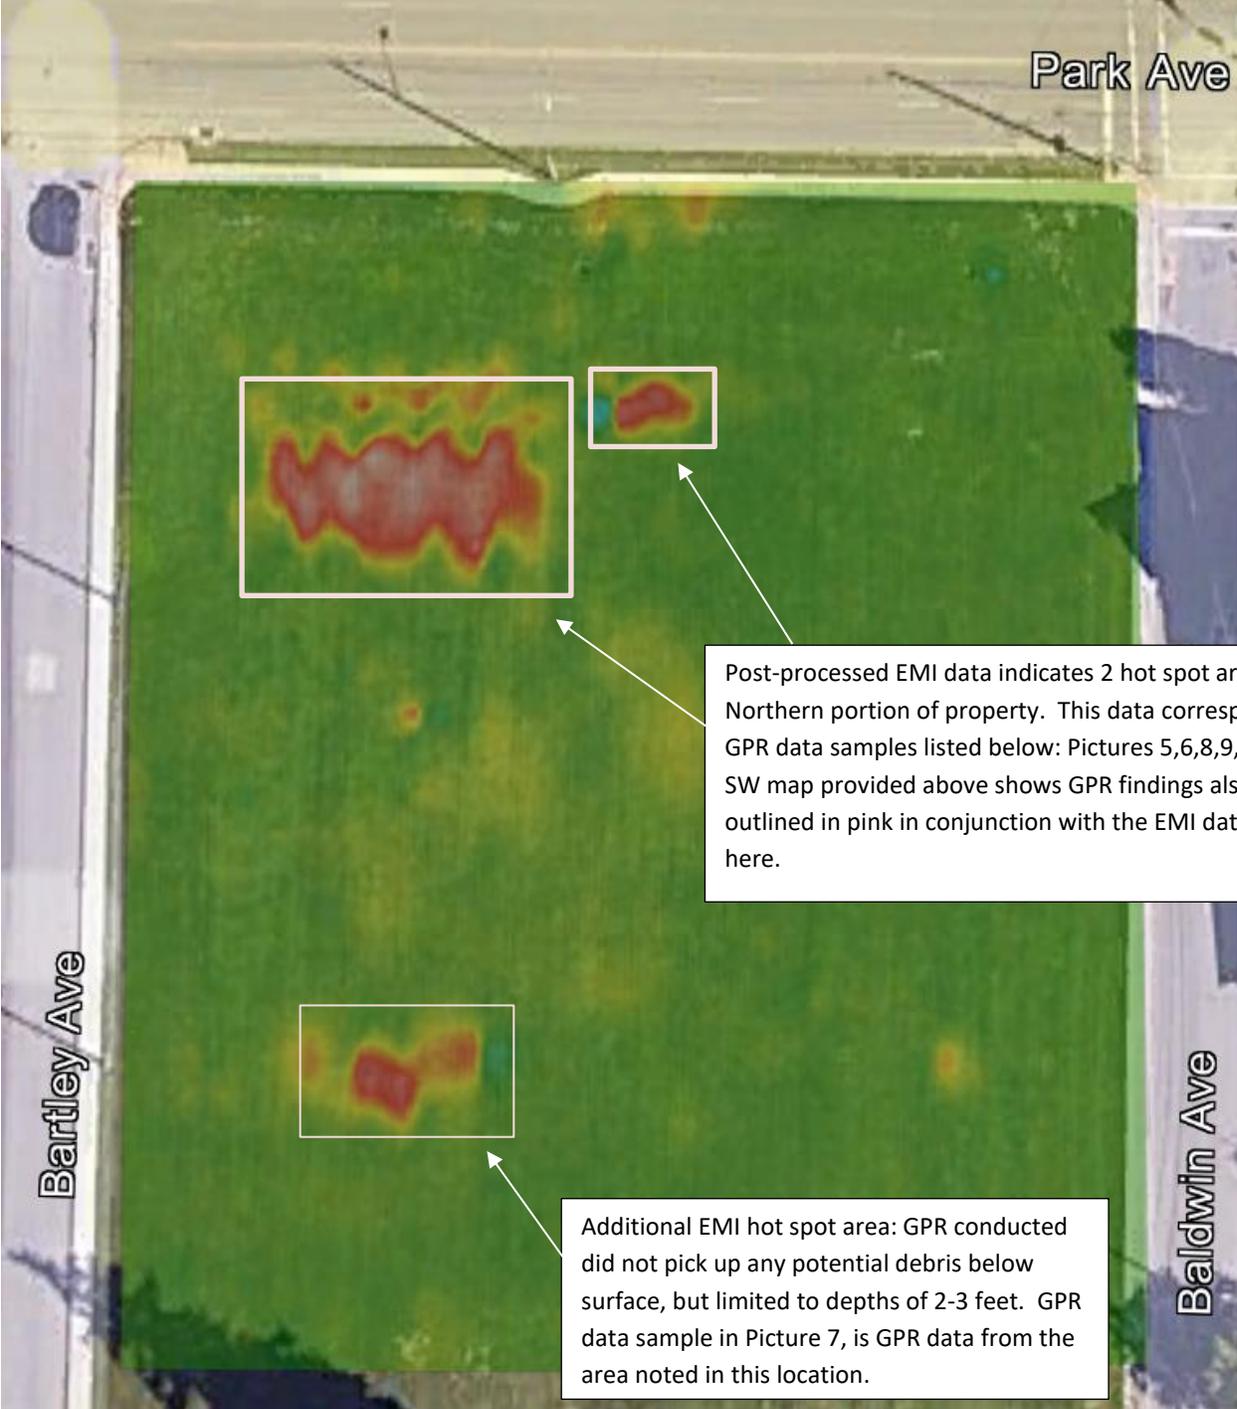
Post-Processed EMI Data

Picture 1: Photo depicts pathway of GPR scan completed in North central area of property where hot spot was detected via EMI. The pink box indicates area of potential buried debris. Photo can be correlated with GPR data sample 10.

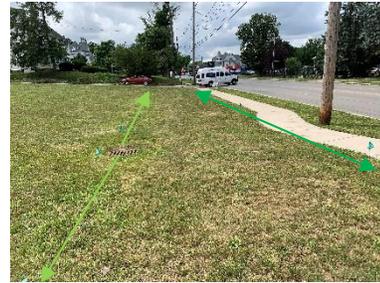
Picture 2: Photo depicts pathway of storm line (light green) and sanitary line (dark green) present within scan area.

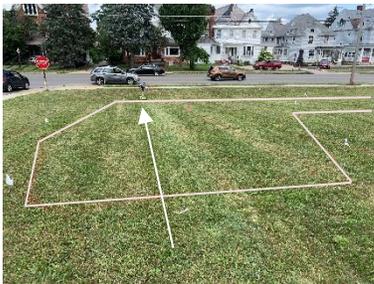
Picture 3: Photo depicts area of property in Northwest corner. This area showed as a hot spot based on EMI data. The pink area shows an outline of potential buried debris below surface. The white arrow indicates pathway of GPR scan.

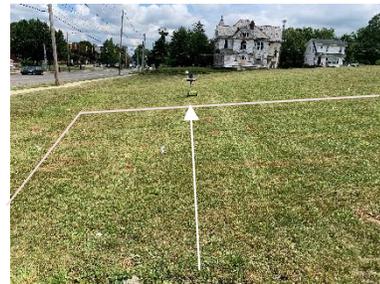
Picture 4: Additional photo of Northwest corner of GPR scan completed in other direction. Pink lines show area of potential buried debris.

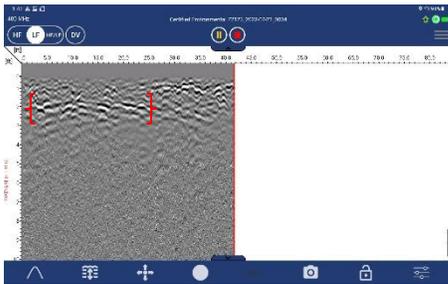
Picture 5: GPR data sample from Northwest area of property. The red brackets indicate potential area of buried debris at ~2 feet deep.

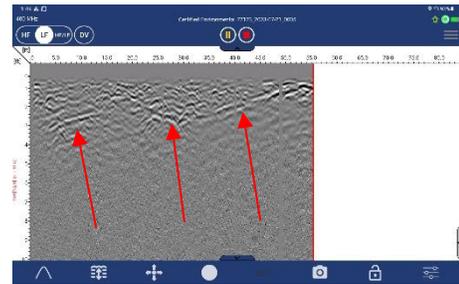
Picture 6: Additional GPR data sample from NW area of property. The red arrows indicate potential buried debris at a depth of ~2-3 feet.

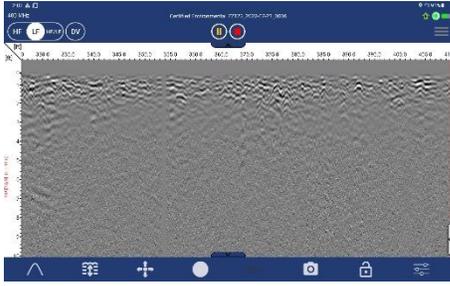
Picture 7: GPR data sample from EMI hot spot area in Southwest portion of property, GPR was unable to verify potential buried debris in this location.

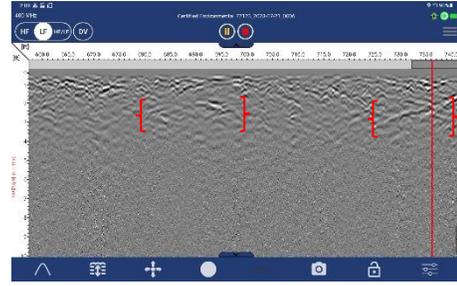
Picture 8: Additional GPR data sample from NW area of property. The red brackets indicate potential buried debris at depth of ~2-3 feet.

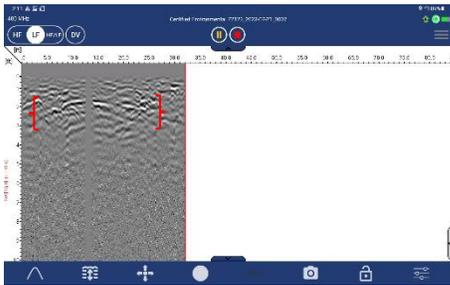
Picture 9: GPR data sample from North Central area of property. The red brackets indicate potential buried debris in the North Central portion of property at a depth of ~2 feet.

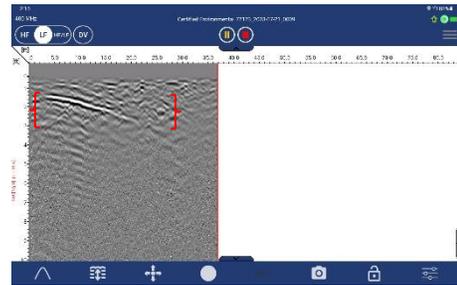
Picture 10: Additional GPR data sample of North Central area of property. The red brackets indicate area of potential buried debris ~1.5 feet in depth.

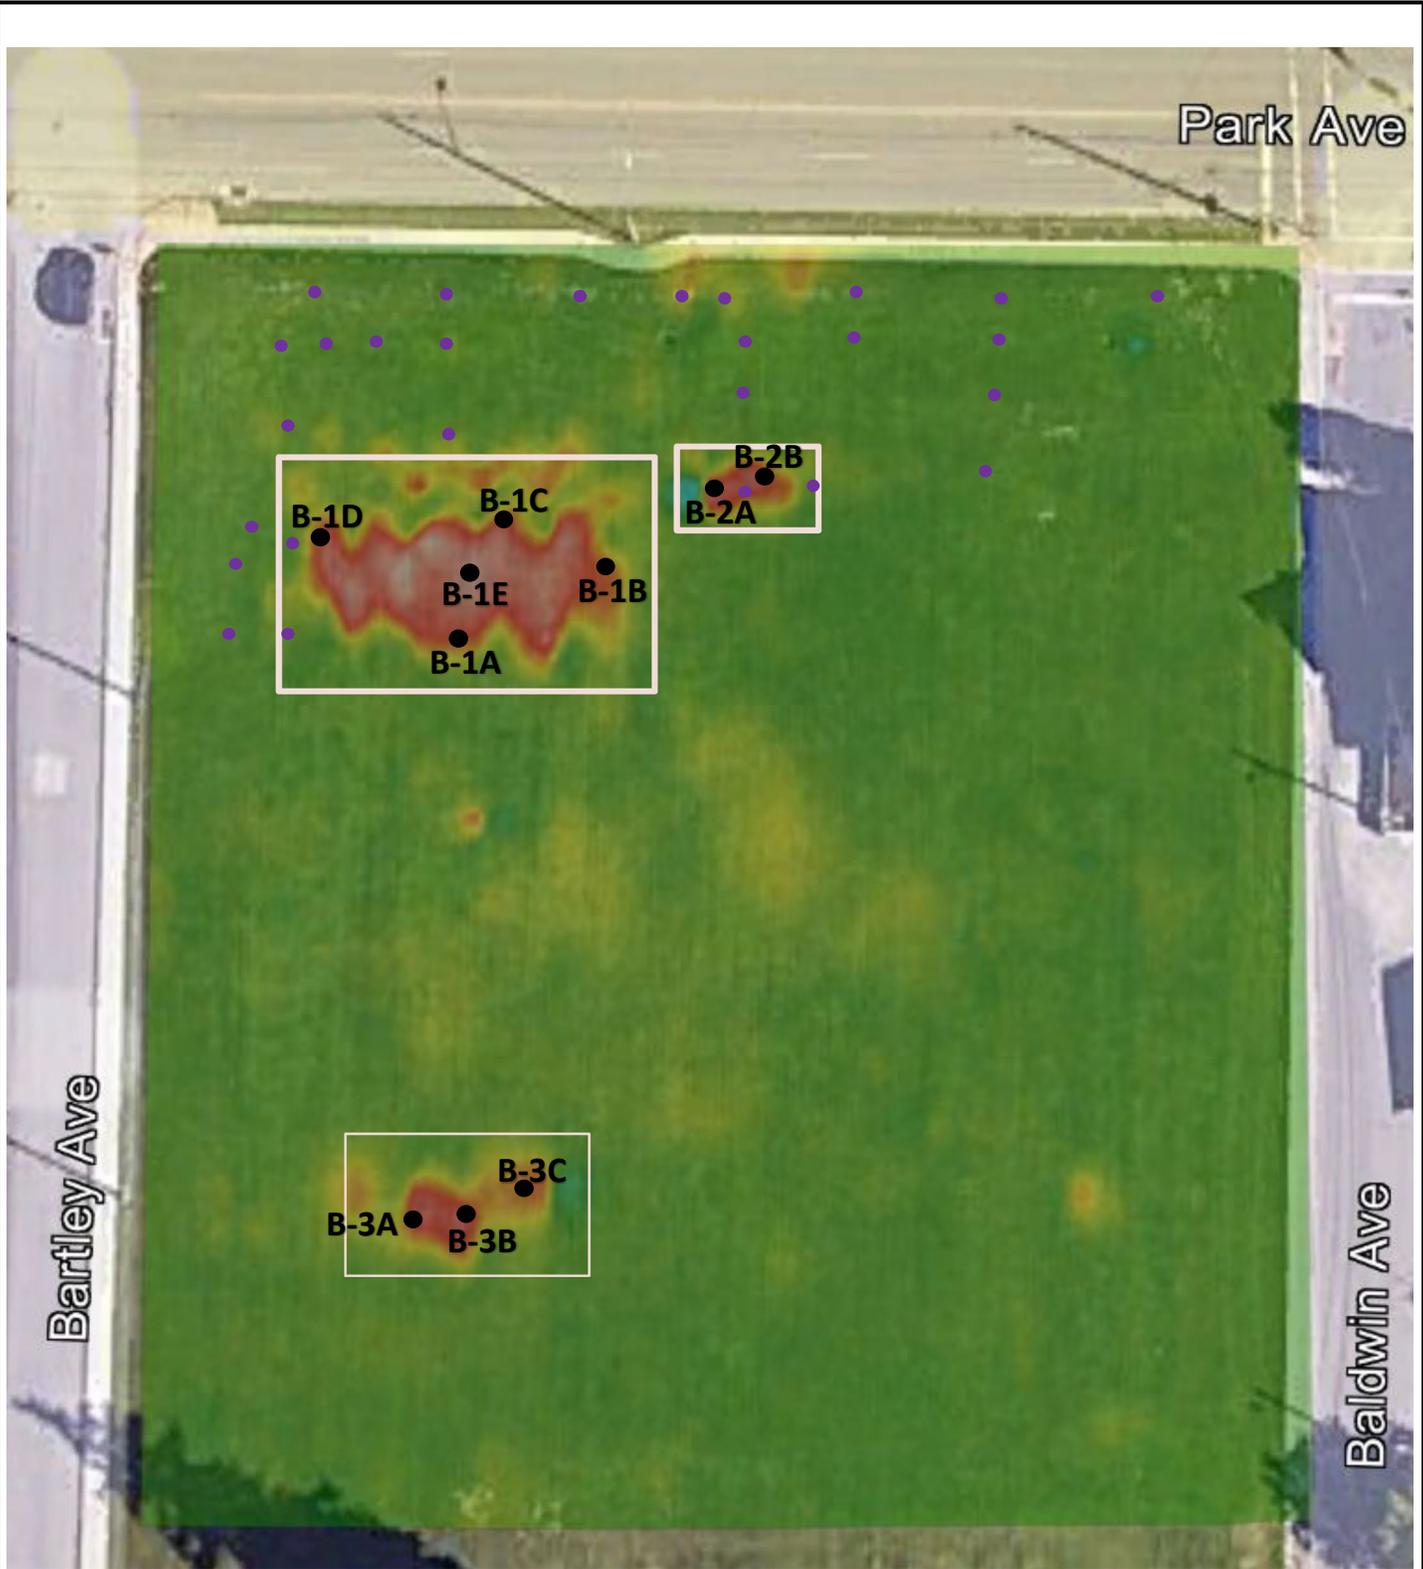
• Approximate Locations of GPRS Flags on August 28

● Boring Location

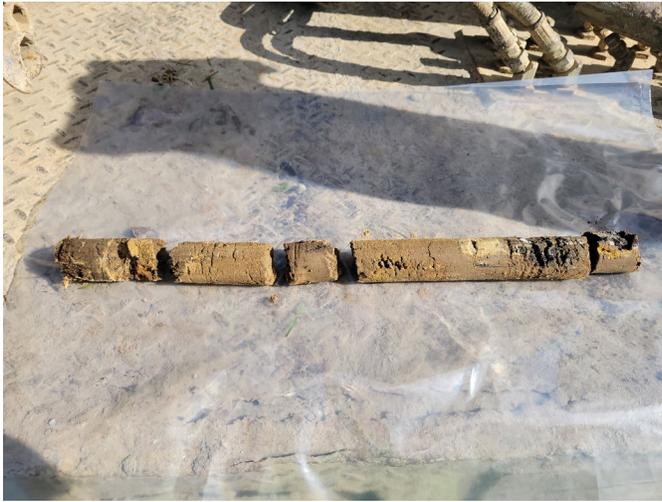
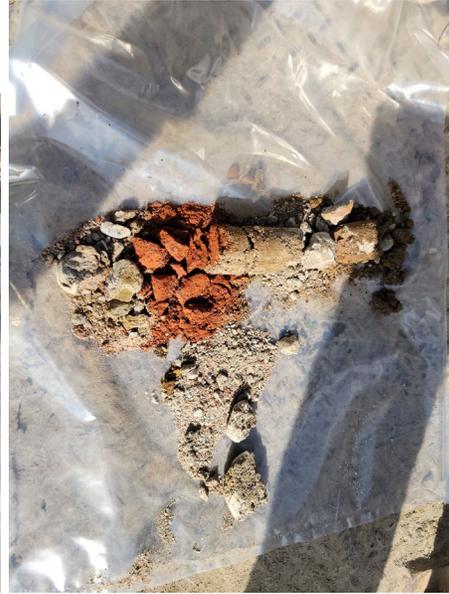
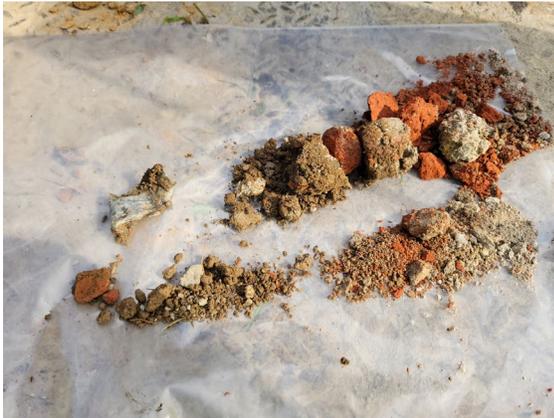
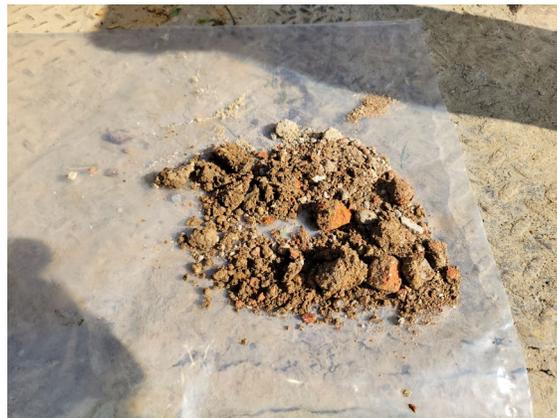
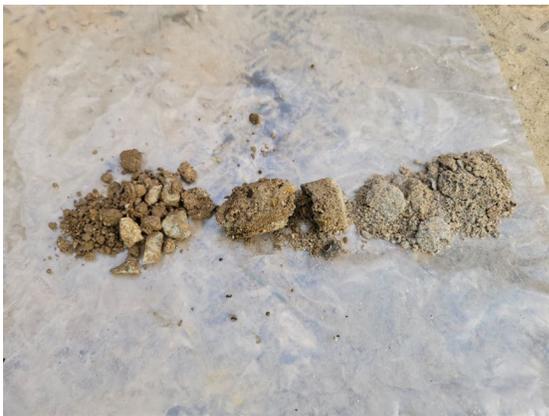
Boring B-1A Split-Spoon Sample Photos

DEPTH	Sample Depths From To	Type of Sample	Blows per 6" on Sampler			Moisture Density or Consist.	Strata Change Depth*		SOIL IDENTIFICATION
			From	To	0-6				6-12
	0.0-1.5	SS	2	2	3	Moist		Topsoil	
								FILL: brown sandy lean clay with asphalt and concrete	
	1.5-3.0	SS	8	14	11	Moist		brown sandy lean clay with gravel	
								from 2' - 3', brick and concrete mixed into the fill	
	4.0-5.5	SS	6	8	6	Moist		mix of brown sandy lean clay, brick, and concrete; piece of metal in the sample	
5									
	6.0-7.5	SS	1	2	2	Moist		mix of brick, clay, concrete, and sand	
	8.0-8.4	SS	50/5"			Moist	8.4		brown sandy lean clay with glass, rock fragments, and concrete
								AUGER REFUSAL: 8.4'	
10								After drilling and pushing auger spoils into the borehole, the borehole was about 2.9' deep.

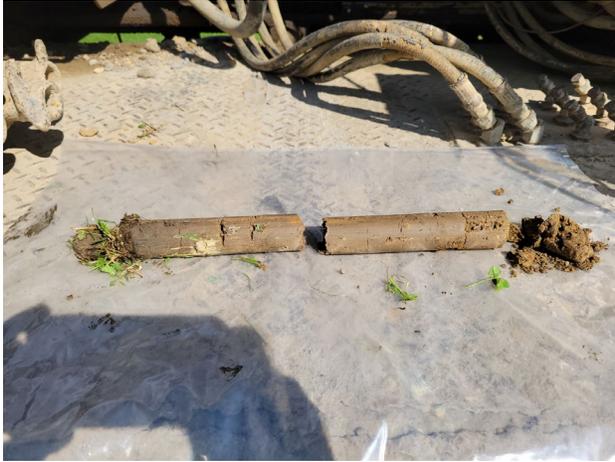
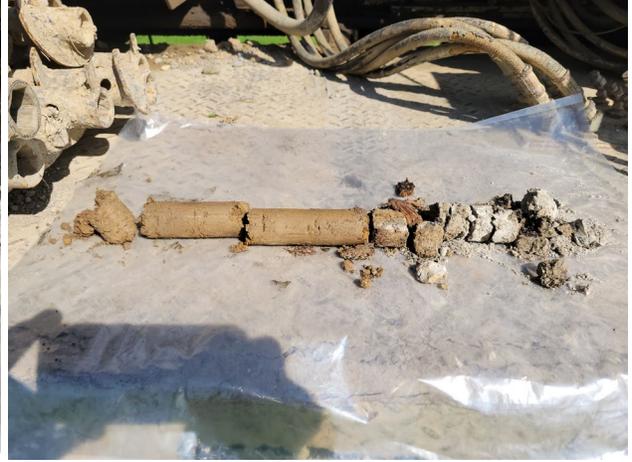
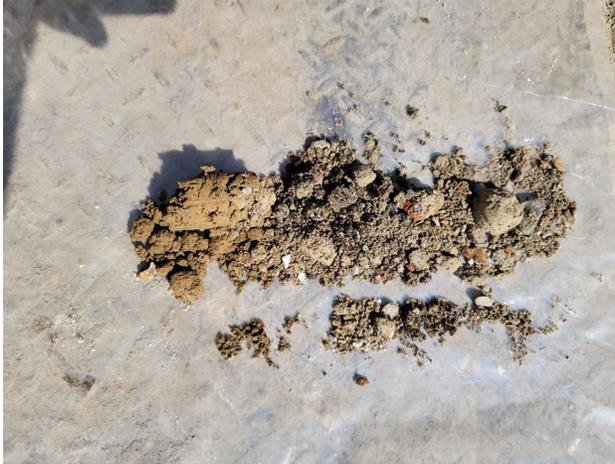
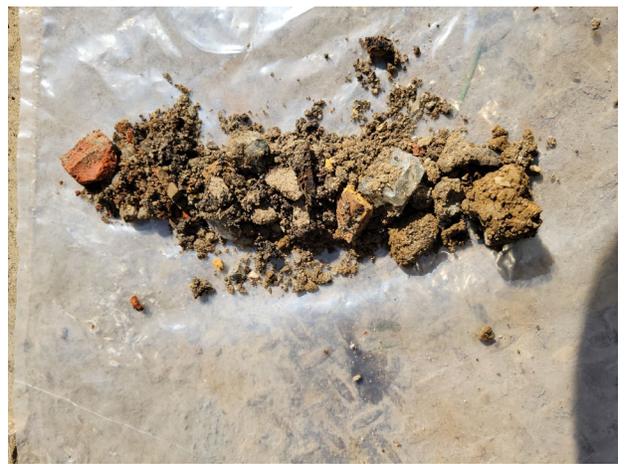
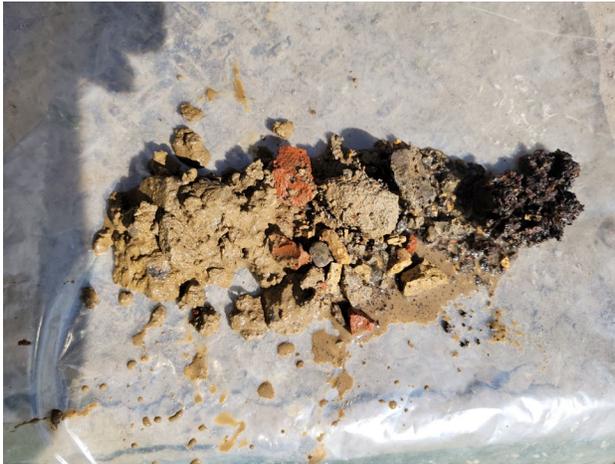
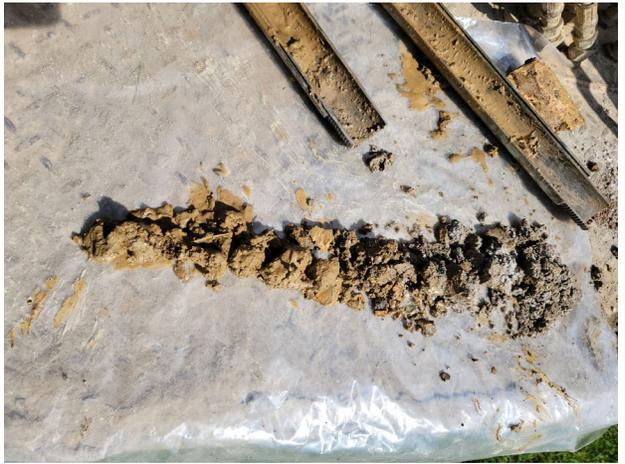
Boring B-1B Split-Spoon Sample Photos

DEPTH	Sample Depths From To	Type of Sample	Blows per 6" on Sampler			Moisture Density or Consist.	Strata Change Depth*		SOIL IDENTIFICATION
			From	To	12-18				Remarks include color, type of soil, etc. Rock-color, type, condition, hardness
	0-1.5	SS	2	2	4	Moist		Topsoil FILL: brown sandy lean clay

1.5-3.0	SS	3	9	9	Moist		near 2.5' depth, wood and concrete mixed with clay and sand	
	4.0-5.5	SS	6	6	3	Moist		mix of sand, concrete, brick, and glass	
5	6.0-7.5	SS	2	2	4	Very Moist		mix of sand, rock fragments, clay, concrete, wood, brick, glass, and topsoil

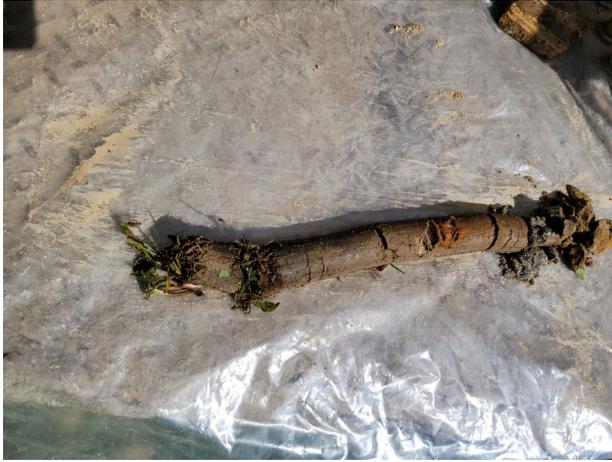
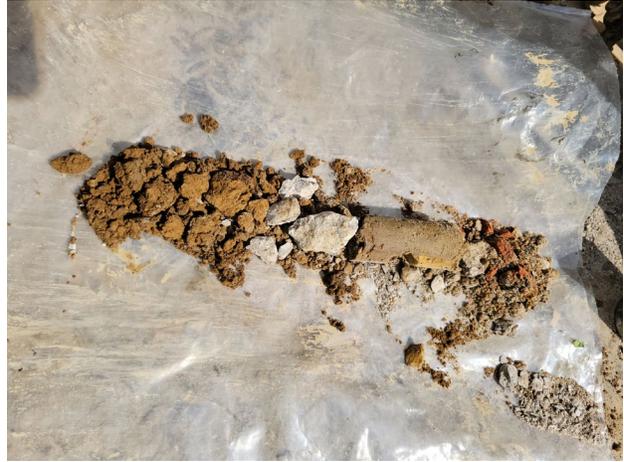
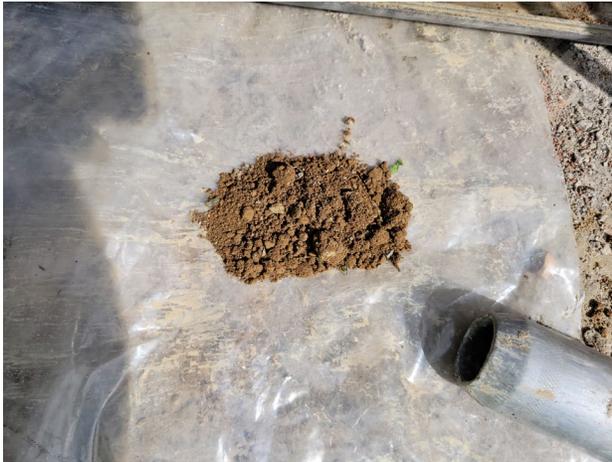
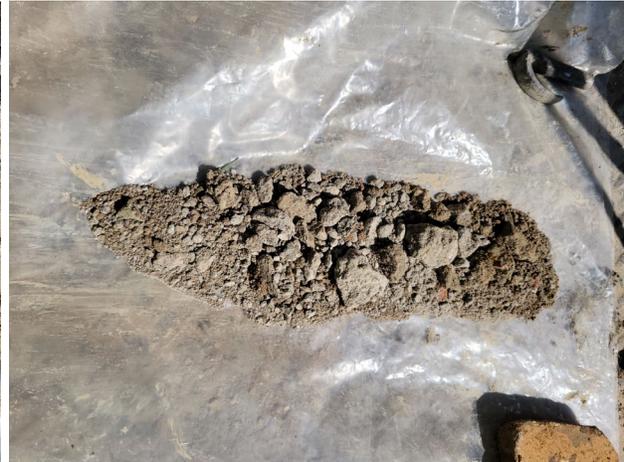
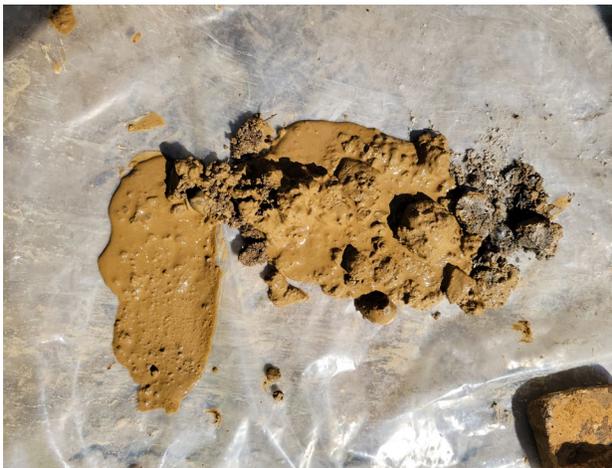
Boring B-1C Split-Spoon Sample Photos

DEPTH	Sample Depths From To	Type of Sample	Blows per 6" on Sampler From To			Moisture Density or Consist.	Strata Change Depth*		SOIL IDENTIFICATION
			0-6	6-12	12-18				Remarks include color, type of soil, etc. Rock-color, type, condition, hardness
	0.0-1.5	SS	3	3	6	Moist		Topsoil FILL: brown sandy lean clay with rock fragments	
	1.5-3.0	SS	10	9	10	Moist		intermixed concrete intermixed sand, concrete, and brick	
	4.0-5.5	SS	6	1	1	Moist		clayey sand	
5	6.0-7.5	SS	6	2	14	Moist		mix of concrete and brick groundwater seepage at 8'	
	8.0-8.3	SS	50/3"			Wet	8.3		mix of sand, concrete, and clay AUGER REFUSAL: 8.3'
10								After drilling and pushing auger spoils into the borehole, the borehole was about 5.1' deep.

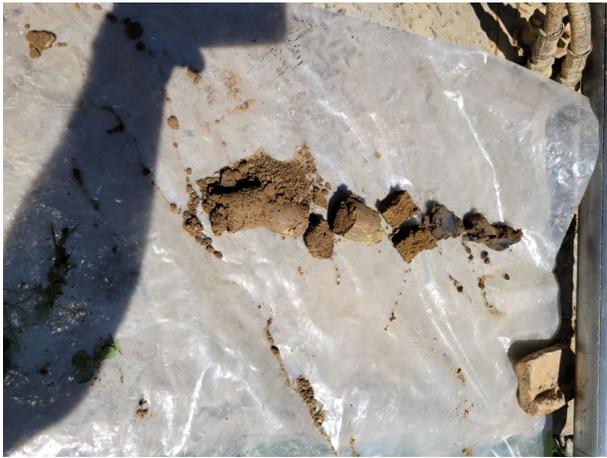
Depth: 1.5' – 3' (with wood from 2.5' – 3' shown)

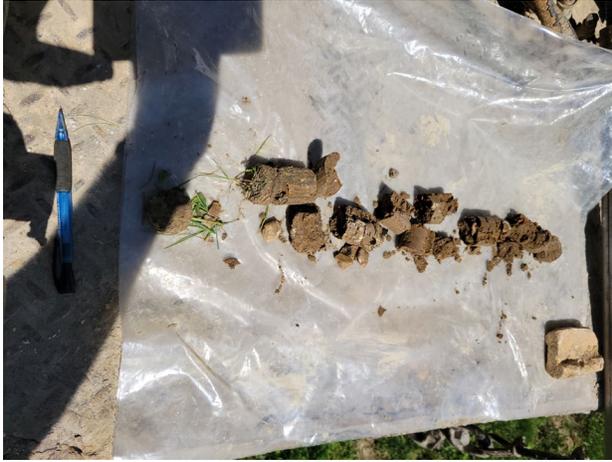
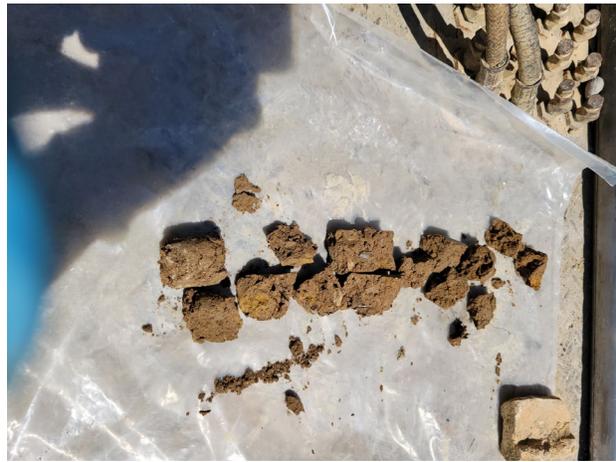
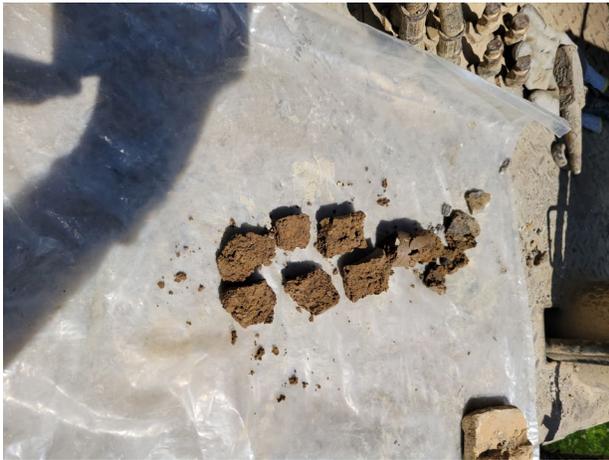
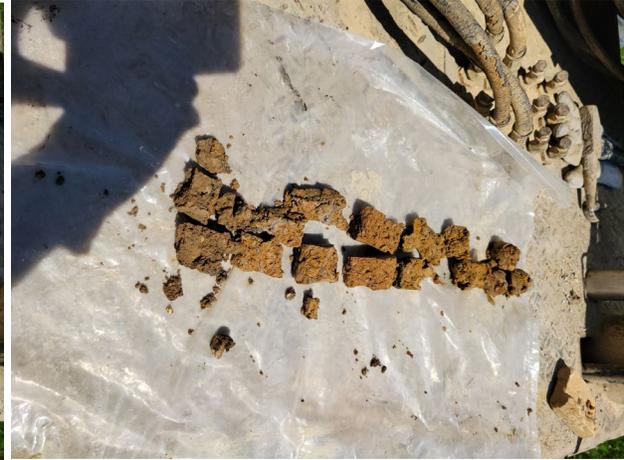
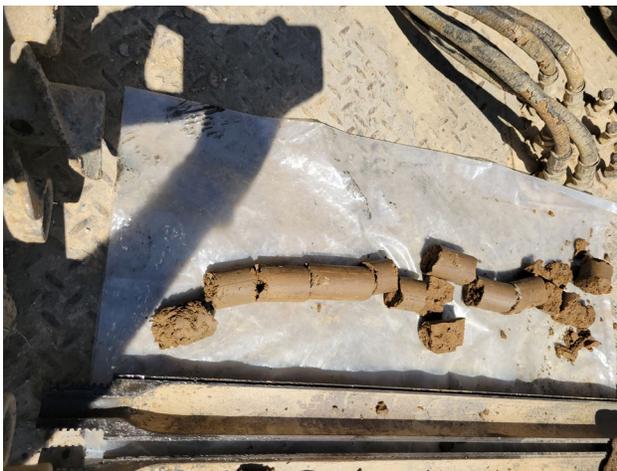
Boring B-3B Split-Spoon Sample Photos

0.0-1.5	SS	6	4	4	Moist		X	Topsoil				
								X	FILL: brown sandy lean clay with trace brick and trace asphalt				
	1.5-3.0	SS	3	3	3	Moist		X					
								X

4.0-5.5	SS	10	14	3	Moist		X	intermixed rock fragments				
5								X					
	6.0-7.5	SS	1	1	1	Very Moist	6.0	/	Brown Lean Clay (CL) - moderate plasticity, few sand, mottled				
								/

8.0-9.5	SS	5	5	6	Moist	8.0	/	Brown Sandy Lean Clay (CL) - glacial till - low to moderate plasticity, some f-c sand, few gravel				
								/					
							9.5	/					
10								/	BOTTOM OF BORING: 9.5'				
								/	After drilling and pushing auger spoils into the borehole, the borehole was about 0.6' deep.
